Graphics for Illustration of accessibility barriers that your establishment might encounter that are preventing costumers with disabilities to access to your goods and services.

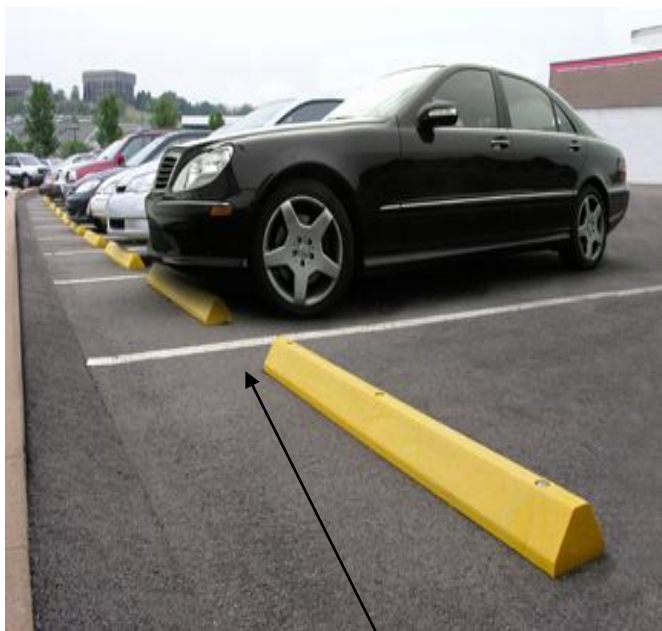
Not Accessible parking space available

This picture illustrate a parking lot with not accessible parking space

Not accessible parking space available for disabled driver

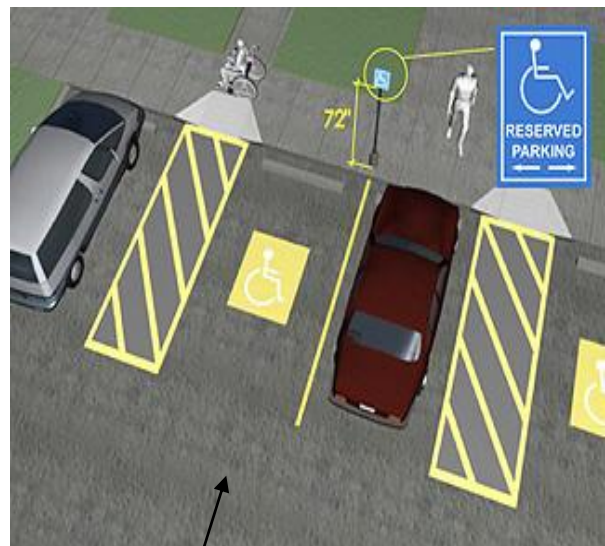
Possible Solution

This picture illustrate a parking lot with accessible parking spaces

Designated an accessible parking space located at accessible route with adjacent accessible aisles and sign

1991 ADAAG: [Section 4.1.2 \(5\) \(a\) \(b\)](#) and [Section 4.6 Parking and Drop-Off Areas](#)

2010 ADA Standards: [Section 208](#) and [Section 209*](#)

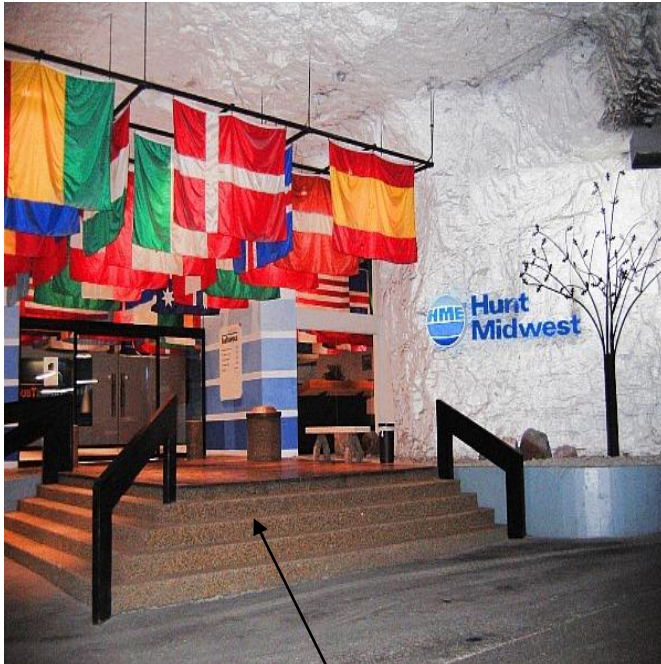
Approaching an Inaccessible Entrance

Building main entrance with five steps

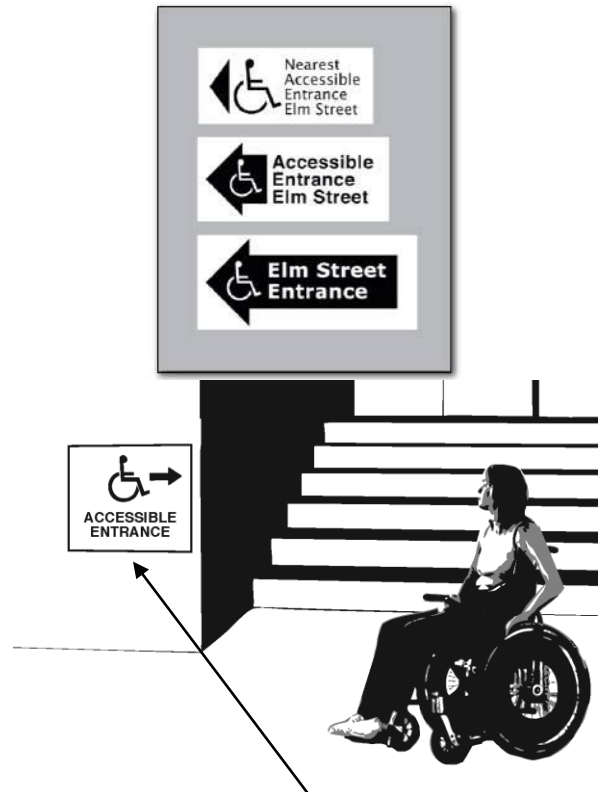
Possible Solution

Install signs on route before people get to inaccessible entrances so that people do not have to turn around and retrace route

1991 ADAAG: [Section 4.1.3 \(16\) \(b\)](#) and [Section 4.30](#)

2010 ADA Standards: [Section 216.3](#) and [Section 703.5](#)

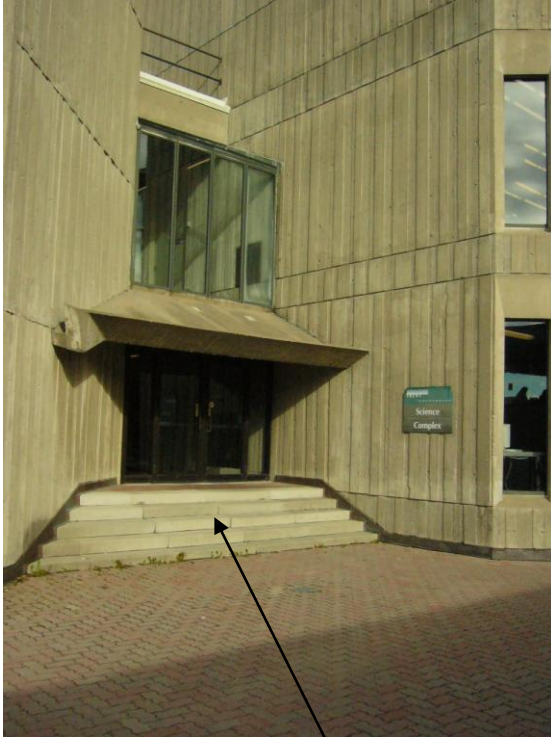
**Inaccessible
Approach/Entrance**

Medical office building with a six steps main entrance

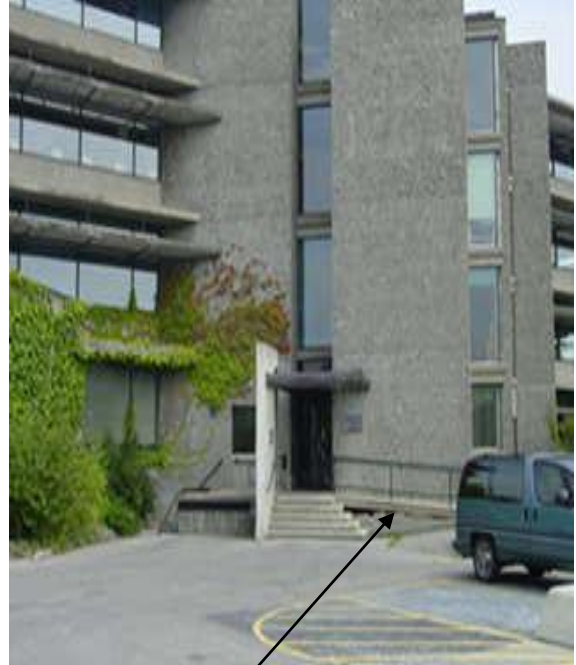
Possible Solution

The Medical office has build a side ramp permanent to make a six steps entrance accessible

1991 ADAAG: [Section 4.8 Ramps](#)

2010 ADA Standards: [Section 405 Ramps](#)

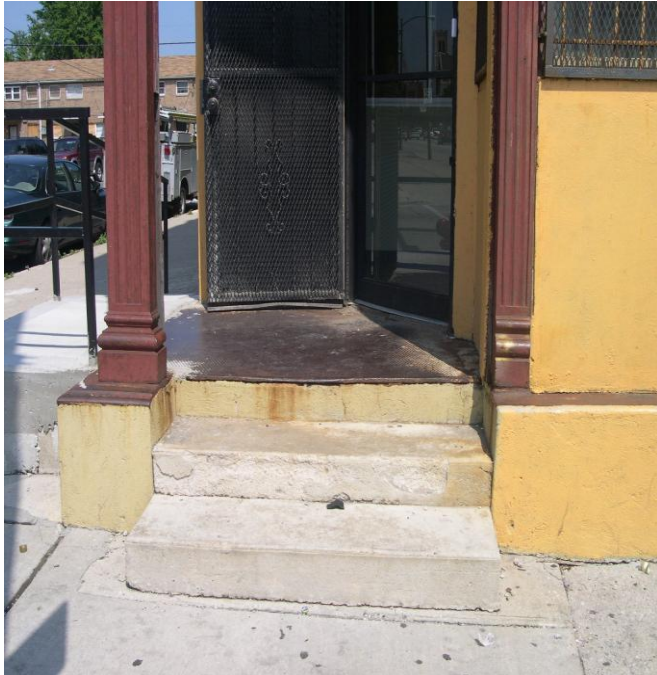
A community health care clinic at an old building has a three steps entrance

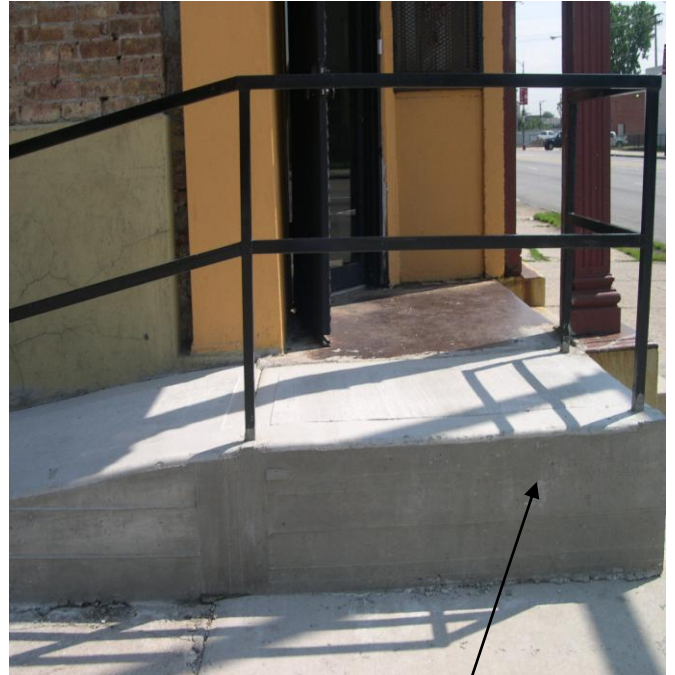
The community health care clinic has build a side concrete ramp to make the entrance accessible

1991 ADAAG: [Section 4.8 Ramps](#)

2010 ADA Standards: [Section 405 Ramps](#)

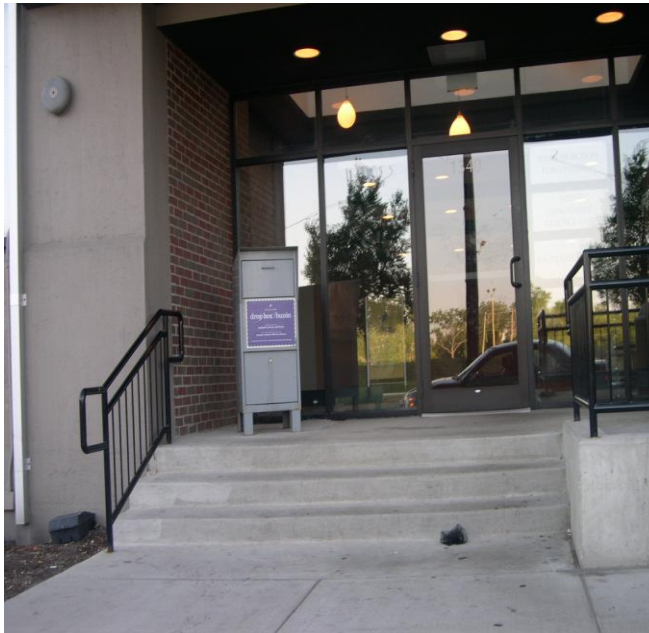
This picture illustrate a state clinic that has three extensive steps at the main entrance

State Clinic three steps entrance

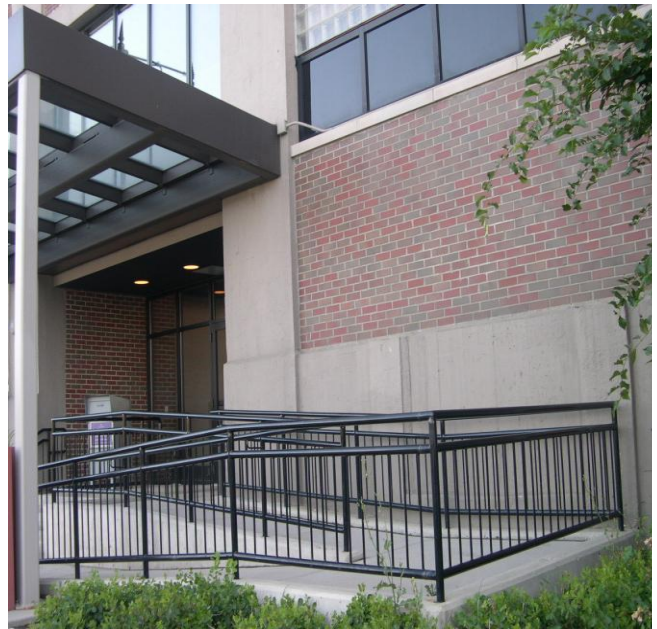
Concrete side ramp with appropriate hand rails and landing transition has been built to make this facility accessible

1991 ADAAG: [Section 4.8 Ramps](#)

2010 ADA Standards: [Section 405 Ramps](#)

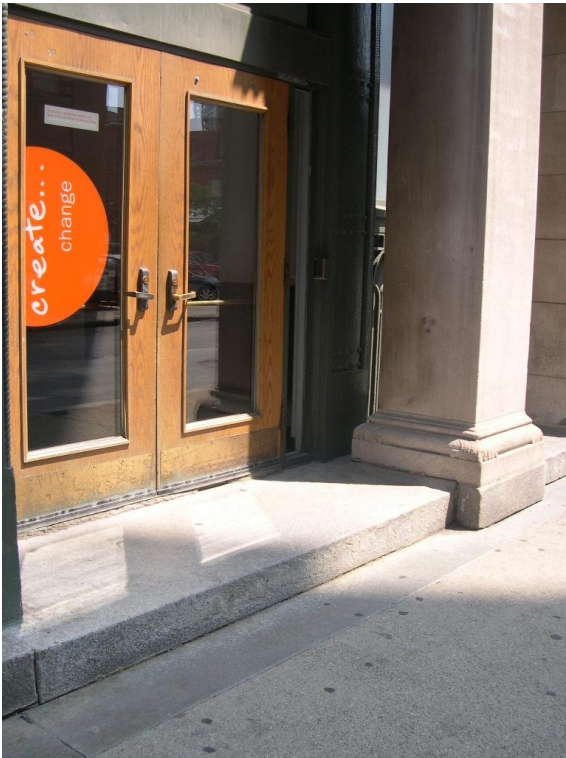
This picture illustrate a not accessible main entrance of a private college located at an old building

4 inches step at the main entrance

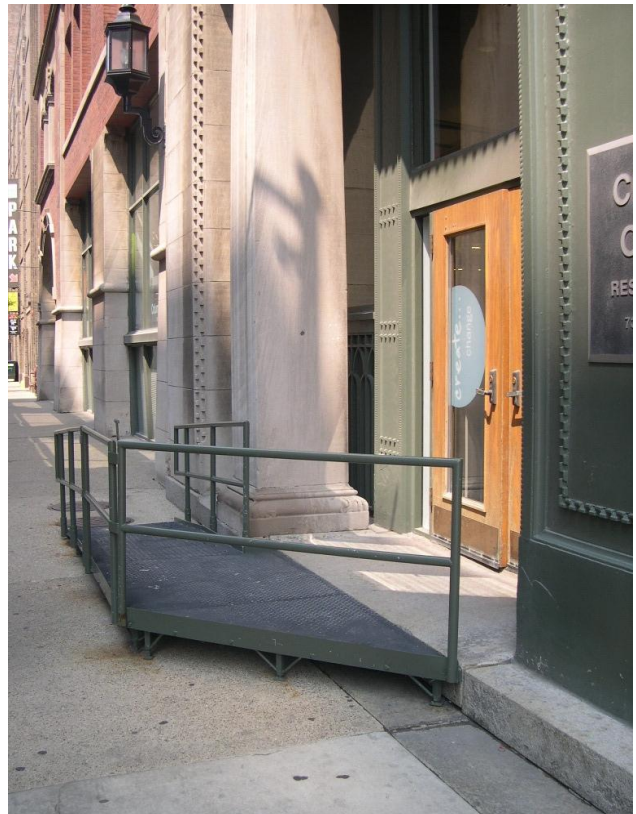
Side portable ramp has been installed to make this college entrance accessible

ADA Title III Citation:

[Section 36.304 Removal of barriers](#)
[\(e\) Portable ramps](#)

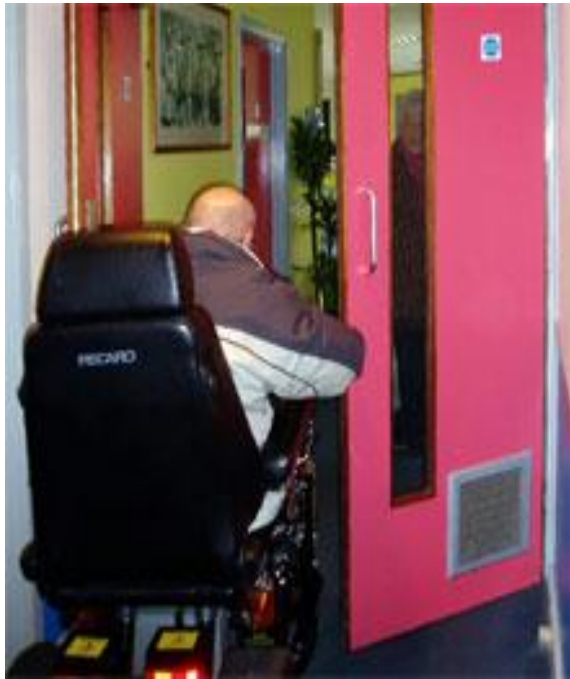
A Person who use mobility aid such as wheelchair, crutches, etc will face difficulty to access an entrance when the pressure of a door is too heavy

Opening Door with too much force

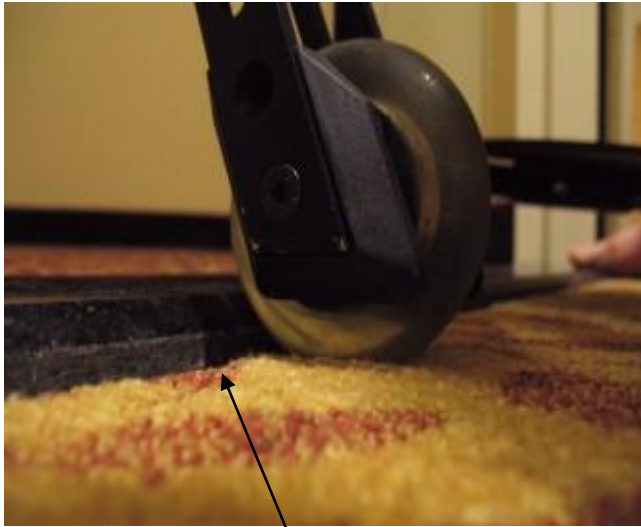
This image illustrate a doorway with a threshold that is more than ¼ inch high

This type of door threshold edge prevent someone who use a wheelchair to have easy access to a doorway

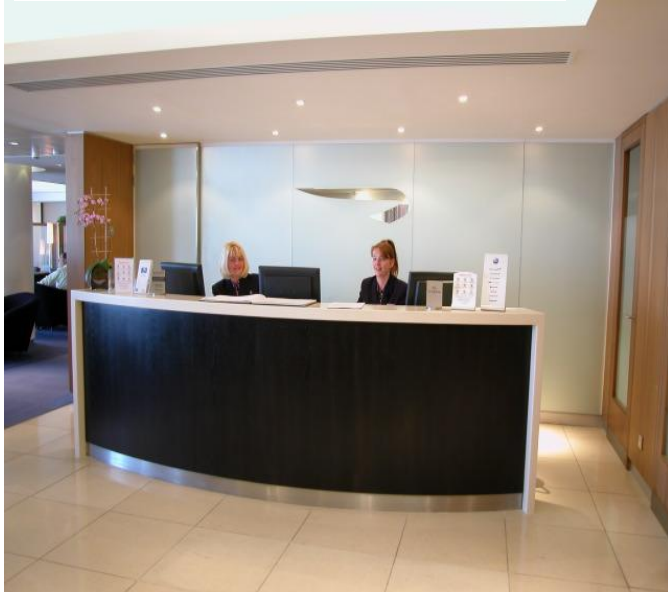
This picture illustrate very modern registration counter but not accessible for visitor who use a seated mobility device

Registration counter too high

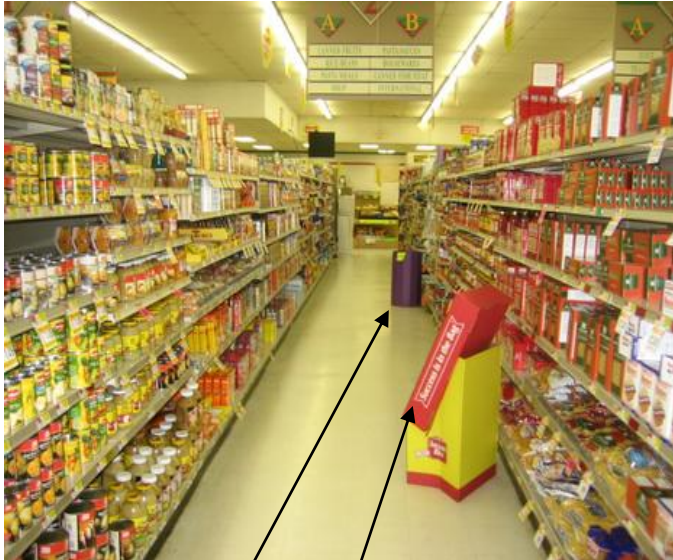
This picture illustrate a store aisle obstructed by standing object

Aisles that are obstructed by standing objects

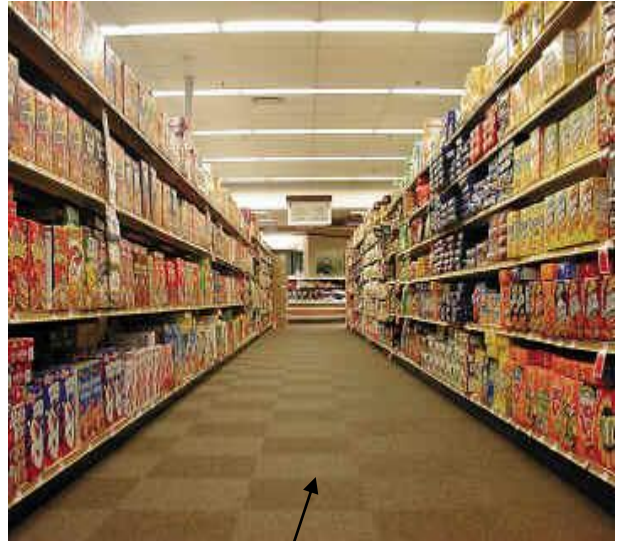
This picture illustrate a store aisle free of obstruction

Clear the aisles of obstructed objects

1991 ADAAG [Section 4.3](#) accessible route

2010 ADA Standards: [Section 402](#) and [Section 403](#)*

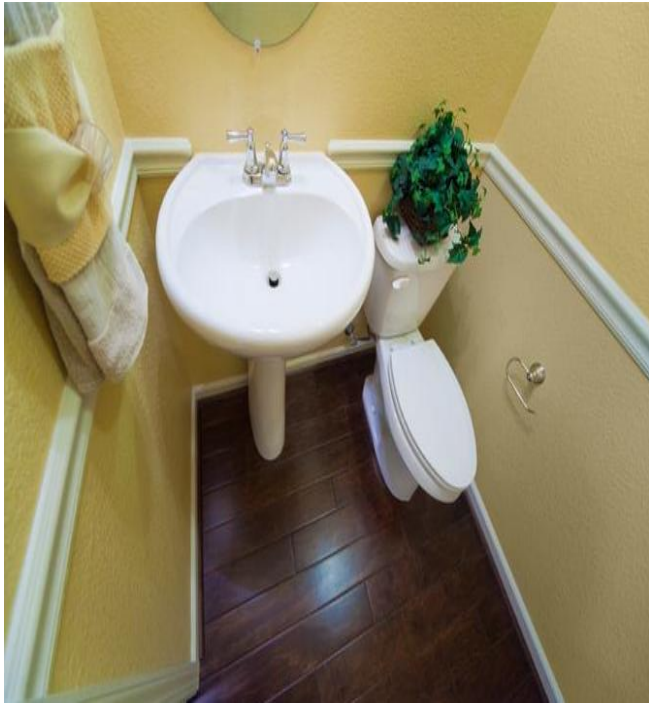
This picture illustrate a restroom that do not has enough clearance and not accessible for a client who use a wheelchair or mobility device

Not clearance space, not grab bars not accessible to clients with disabilities

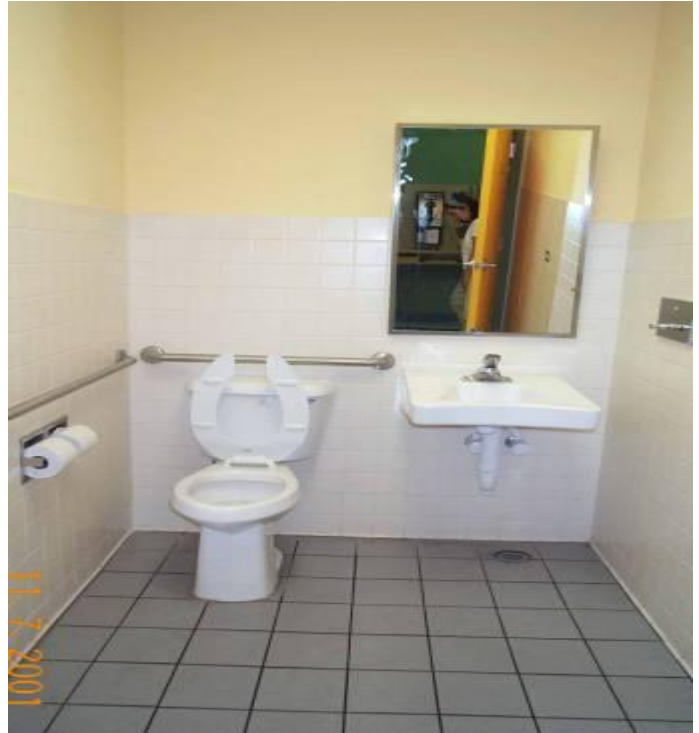
Accessible Restroom, clear floor space, grab bars, flush controls on the open side of the water close.

1991 ADAAG: [Section 4.16](#), [section 4.17](#) and [section 4.19](#)

2010 ADA Standards: [Section 213](#), [Section 603](#), and [Section 604](#)*
